Manhole Inspection Summary

Manhole # S4100_022MH

Insp Date: **2/28/07 3:10 PM**

Location Address: **2143 HARFORD RD**

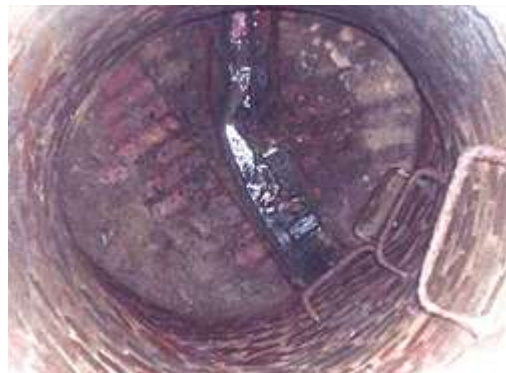
Top View

Corroded and missing steps. Evidence of surcharge - Bench debris. Channel debris.

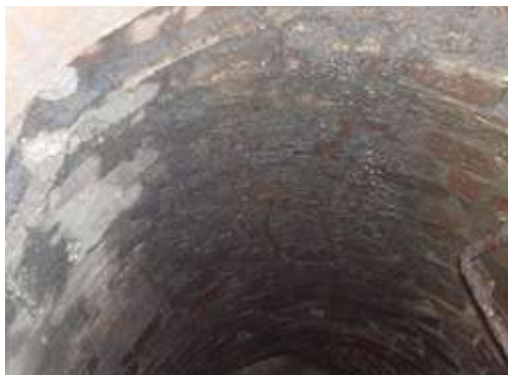
Defect

Frame leaks. Adjustment deterioration and infiltration.

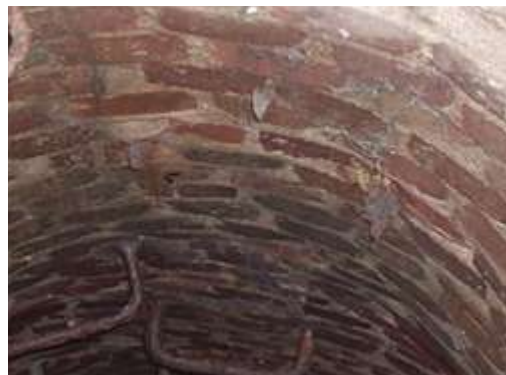
Defect

missing step

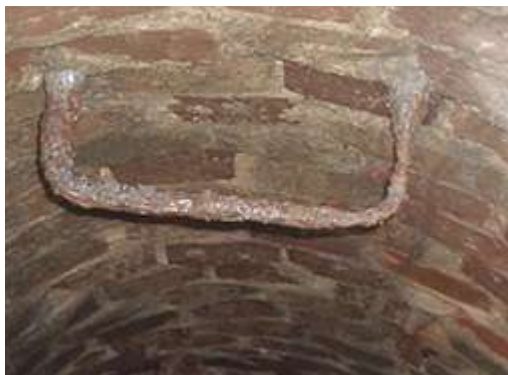
Defect

corroded steps

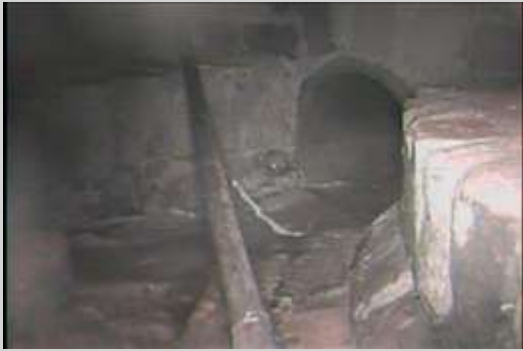
8 in. Circular Gravity Sewer Pipe Out @ 12 O'Clock

Invert Depth: **10.41** (ft.) Flow Characteristics: **Slow**

Deposits: ☒ None ☐ Mud ☐ Sludge ☐ **Debris** ☐ Grease

Infiltration: **Evidence** Pipe Seal Cond: **Unknown**

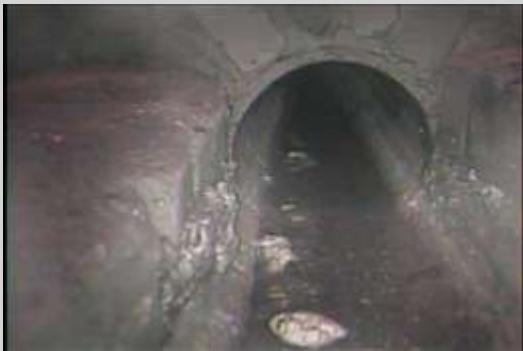
8 in. Circular Gravity Sewer Pipe In @ 5 O'Clock

Deposits: ☐ None ☒ **Mud** ☐ Sludge ☒ **Debris** ☒ **Grease**

Silt Depth: **0** (in.) Deposits Extent: **Light**

Infiltration: **None** Pipe Seal Cond: **Cracked**

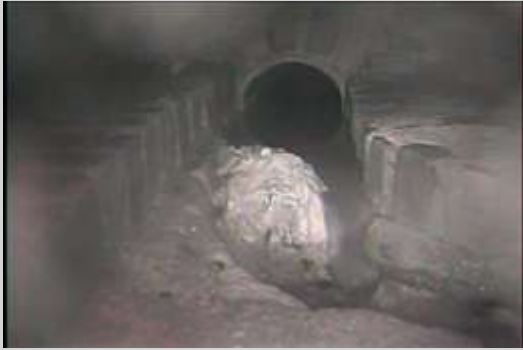
Pipe In @ 11 O'Clock

Deposits: ☐ None ☐ Mud ☐ Sludge ☒ **Debris** ☐ Grease

Deposits Extent: **Heavy**
